Mayhill WTW

emergency works

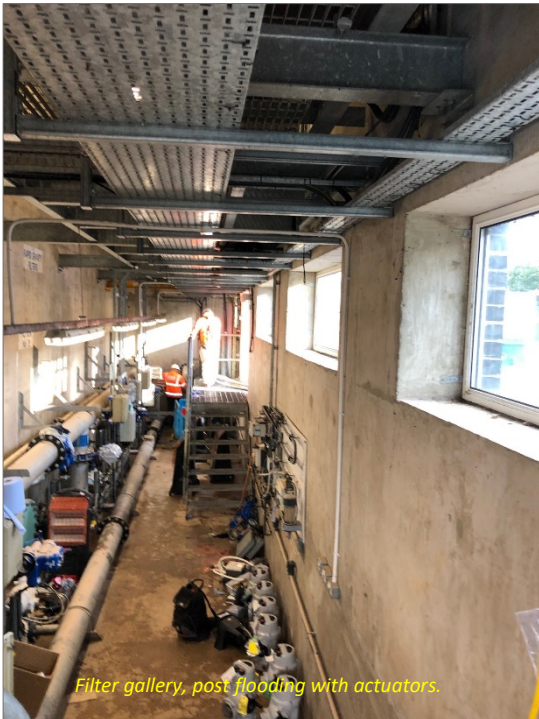
Filter gallery, post flooding with actuators.
