Mayhill WTW

emergency works

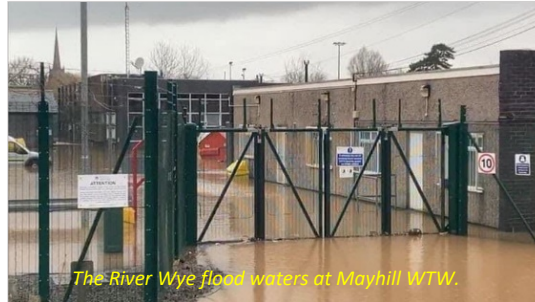
Our teams waited for the clean-up operations

to be completed and floors cleaned of river silt and made safe.
